CITY OF BAKER CITY

Weekly Update January 4, 2019

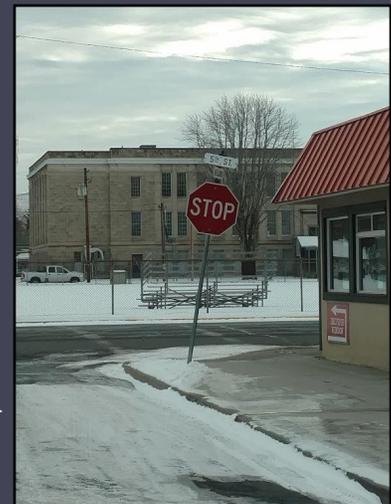
Many signs are damaged each winter. This stop sign located at the intersection of 5th and Broadway is the responsibility of O.D.O.T.

They performed temporary repair work this week and plan to replace the sign and post in the spring.

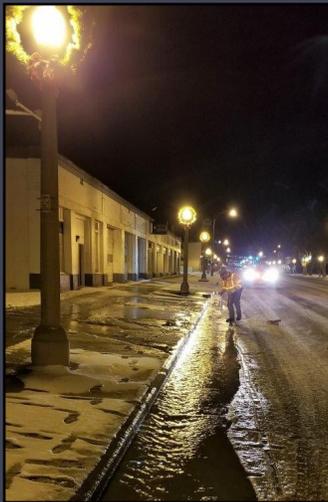
← Justin trying to locate the sound of running water coming from the broken pipe.

Fortunately an Emergency Repair Kit was purchased many years ago by a former Water Foreman. Justin was able to locate the kit, determine which combination of repair clamps to use and the leak was successfully stopped.

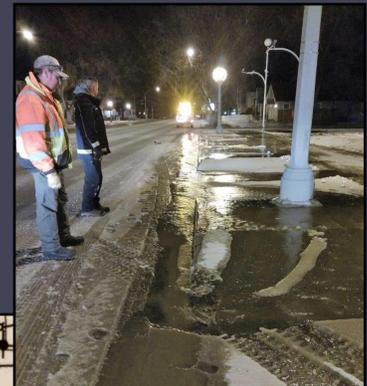
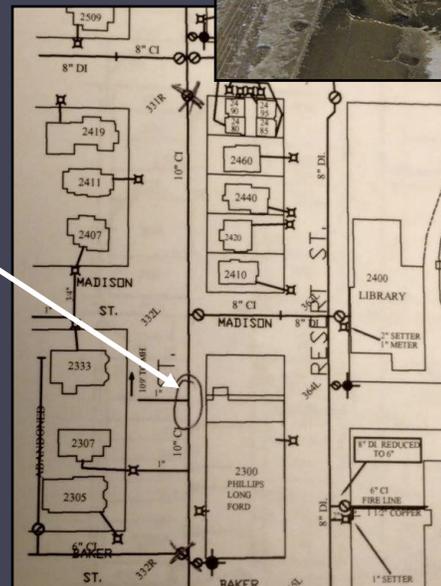
Dennis received a phone call from police dispatch late Wednesday night about a possible water leak coming from under the Main Street concrete. Justin met Dennis on site and they discovered that there was indeed a major water leak on the east side of Main Street between Baker and Madison Streets.

This is a map showing the approximate location of the water line break (circled area) and control valves in the area.

Main line control valves in the area were turned down to the point where there was just enough positive pressure so that there was no chance outside ground water or other contaminants could enter the line through the break. All valves worked properly and the leak was isolated.

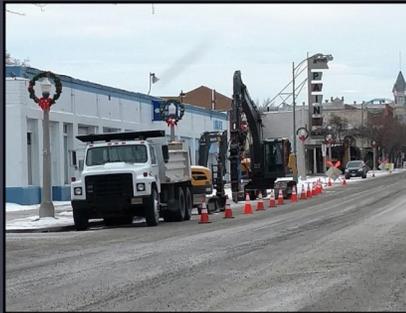
Main Street was constructed with 10" of concrete over 8" of crushed rock, a layer of structural fabric and 6" of lime treated base. The concrete is too thick for a normal concrete construction saw to cut through effectively. It was time to call in the "big guns" of concrete demolition.

A-core cutting the concrete with their industrial strength saw.

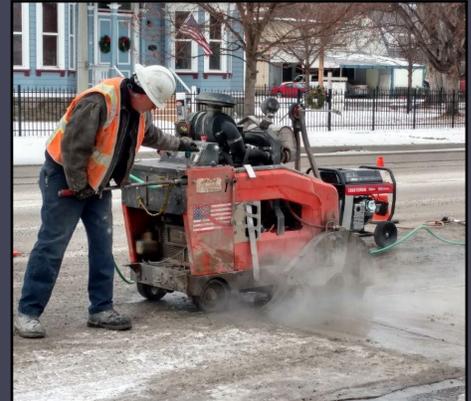
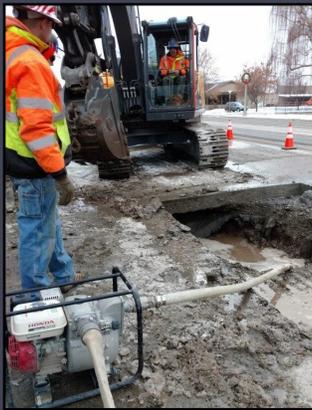
Water seemed to be coming from just a little further to the south after the first excavation was performed.

The water was pumped from the trench and the pipe examined.

Justin operated the Case 160 excavator to break-up the concrete and excavate around the water line.

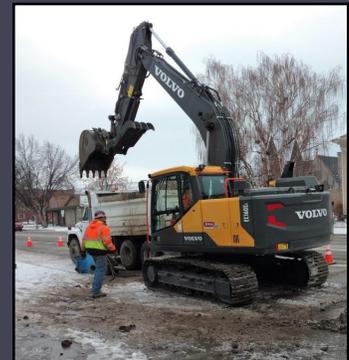
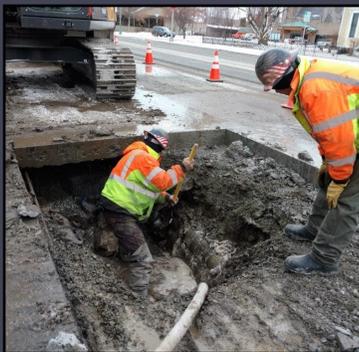
Blain searching for the leak under the concrete.

The emergency repair kit came in very handy for the repair.

The chart described the combination of bands needing to be used when repairing a pipe the size of the 10" cast iron in Main Street.

A-core from Boise was called - unfortunately they didn't have an opening to come do the work for at least two weeks. Fortunately Jeff from A-core offered his mechanic to come over and do the saw cutting for us since it was an emergency situation. Saw cutting went well but the water leak itself was difficult to locate. Additional concrete was cut and the leak finally located. The repair clamp was slightly undersized for the repair. It was designed to repair 10" steel lines. This was a 10" cast iron line.

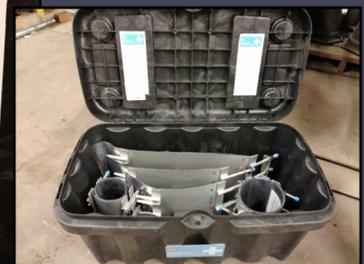
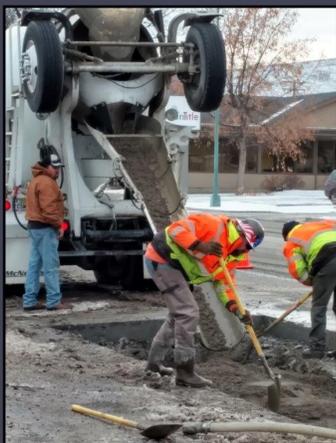
As required by O.D.O.T. specifications - CLSM (Controlled Low Strength Material) a very low strength concrete, was used as backfill for the repair. Justin and Brian are pictured here helping with the repair.

Insulation blankets are used to cover the repair while the CLSM cures.

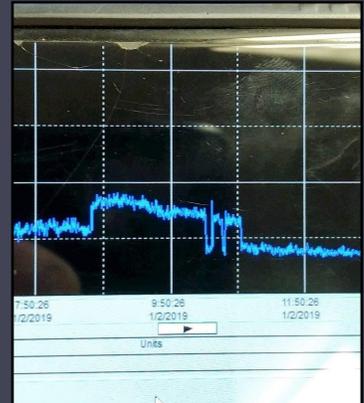
In this photo you can see the precise hour that the water leak on Main Street started. Each horizontal line on the graph represents 1,000,000 gallons of water per 24 hours flow (or approximately 700 gallons per minute).

Each vertical line represents one hour of time. The leak began around 8:43 p.m. The leak was discovered and reported to police dispatch. Dennis and Justin arrived on the scene and worked to close valves around 10:20 p.m. The leak was turned off around 11:00 p.m.

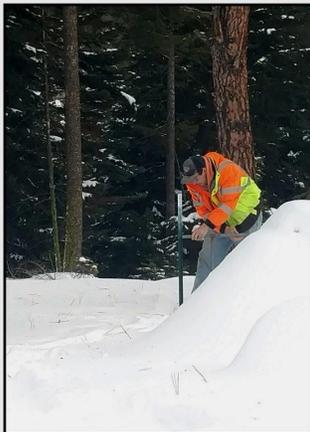
Scott is adjusting a valve at the Elk Creek settling tank to bring additional water to town Thursday morning.

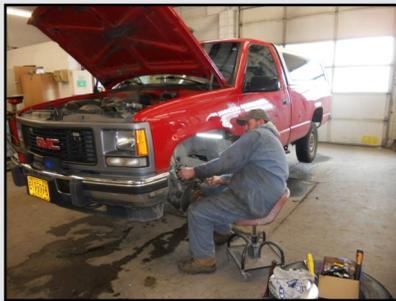
Nate replaced the front brakes and rotors on this vehicle. It is now back in service.

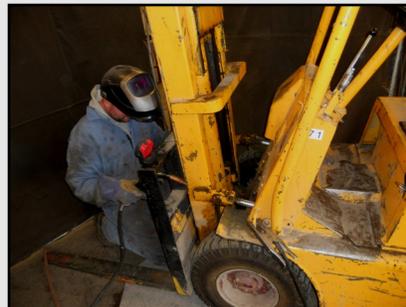
Wes and Scott repaired a crack in the frame of the forklift and fish plated it.

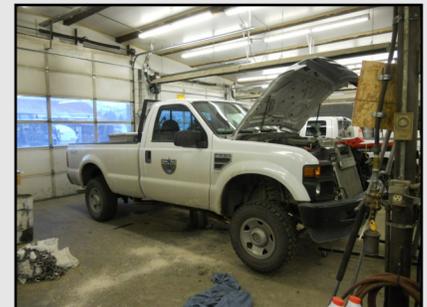
Nate serviced, cleaned, and checked over the shop truck. It is now back in service.

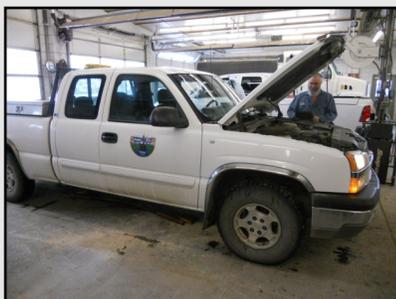
Scott replaced the headlight and tested both the battery and alternator. ←

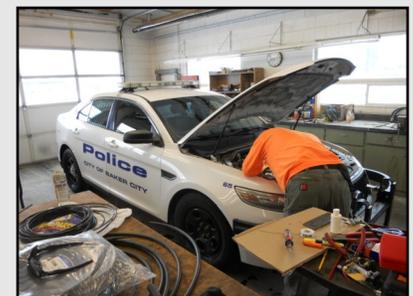
Wes and Scott replaced the passenger side headlight harness on this cruiser. →
